DEPARTMENT OF TRANSPORTATION**DIVISION OF ENGINEERING SERVICES**

Contract #: 04-0120F4Cty: SF/ALA Rte: 80 PM: 13.2/13.9File #: 69.28**WELDING INSPECTION REPORT****Resident Engineer:** Pursell, Gary**Address:** 333 Burma Road**City:** Oakland, CA 94607**Report No:** WIR-001676**Date Inspected:** 08-Mar-2008**Project Name:** SAS Superstructure**OSM Arrival Time:** 630**Prime Contractor:** American Bridge/Fluor Enterprises, a JV**OSM Departure Time:** 1730**Contractor:** Zhenhua Port Machinery Company, Ltd (ZPMC), Changxing Island **Location:** Shanghai, China**CWI Name:** Huang Wen-Pang**CWI Present:** Yes No**Inspected CWI report:** Yes No N/A**Rod Oven in Use:** Yes No N/A**Electrode to specification:** Yes No N/A**Weld Procedures Followed:** Yes No N/A**Qualified Welders:** Yes No N/A**Verified Joint Fit-up:** Yes No N/A**Approved Drawings:** Yes No N/A**Approved WPS:** Yes No N/A**Delayed / Cancelled:** Yes No N/A**Bridge No:** 34-0006**Component:** OBG**Summary of Items Observed:**

Bay 3 OBG:

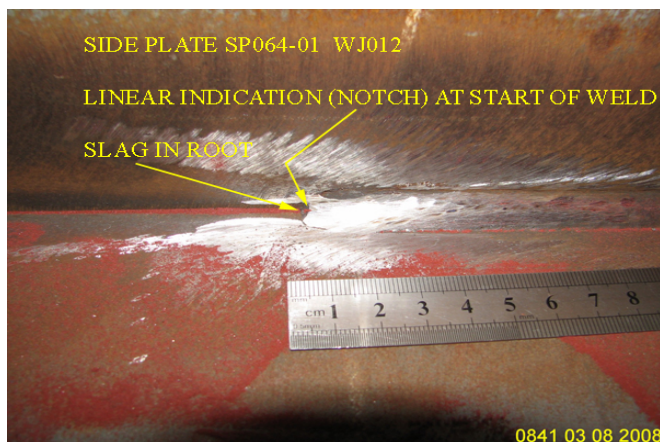
The QA Inspector randomly observed ZPMC Non-Destructive Testing (NDT) Technician Zhou Dongyun, utilizing the Magnetic Particle Testing (MT) Method, to examine Weld Joint (WJ) Numbers 001 through 012 on Side Plate SP064-01. Mr. Zhou observed a linear indication at the start of WJ 012 and marked the area. The QA Inspector also randomly observed the indication and it appeared to be a slag inclusion in that started in the root of WJ 012, and could be seen visually. Mr. Zhou did not accept the welds on SP064-01 at this time. The attached photograph provides additional detail.

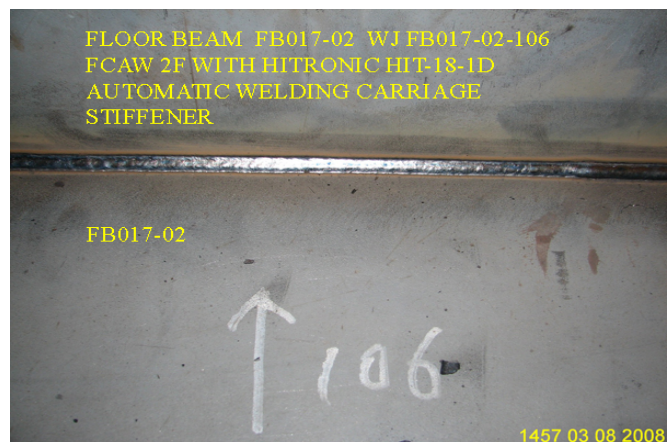
The QA Inspector randomly observed ZPMC Welders Hong Yongli ID Number 044801 and Chen Chuan Zong ID Number 044824, utilizing the FCAW Process with ZPMC Weld Procedure Specification (WPS) WPS-B-T-2132-3 in the 2F (Horizontal Fillet) position with Hitronic HIT-18-1D Automatic Welding Carriages, to weld various stiffeners to Floor Beam Sub-Assembly FB017-02. The QA Inspector randomly observed ZPMC CWI Huang Wen-Pang monitoring weld parameters. The QA Inspector also randomly observed welding parameters and they are as follows: 290 amps, 29.3 volts with a travel speed of 415 millimeters (mm) per minute for Mr. Hong and 291 amps, 29.6 volts with a travel speed of 413 mm per minute for Mr. Chen. Weld parameters appeared to comply with contract requirements. The attached photograph provides additional detail.
